APOLLO 6
ANOMALY REPORT NO. 10

SERVICE MODULE QUAD C
TEMPERATURE EXCURSIONS

APOLLO 6

Prepared by: Apollo 6 Mission Evaluation Team

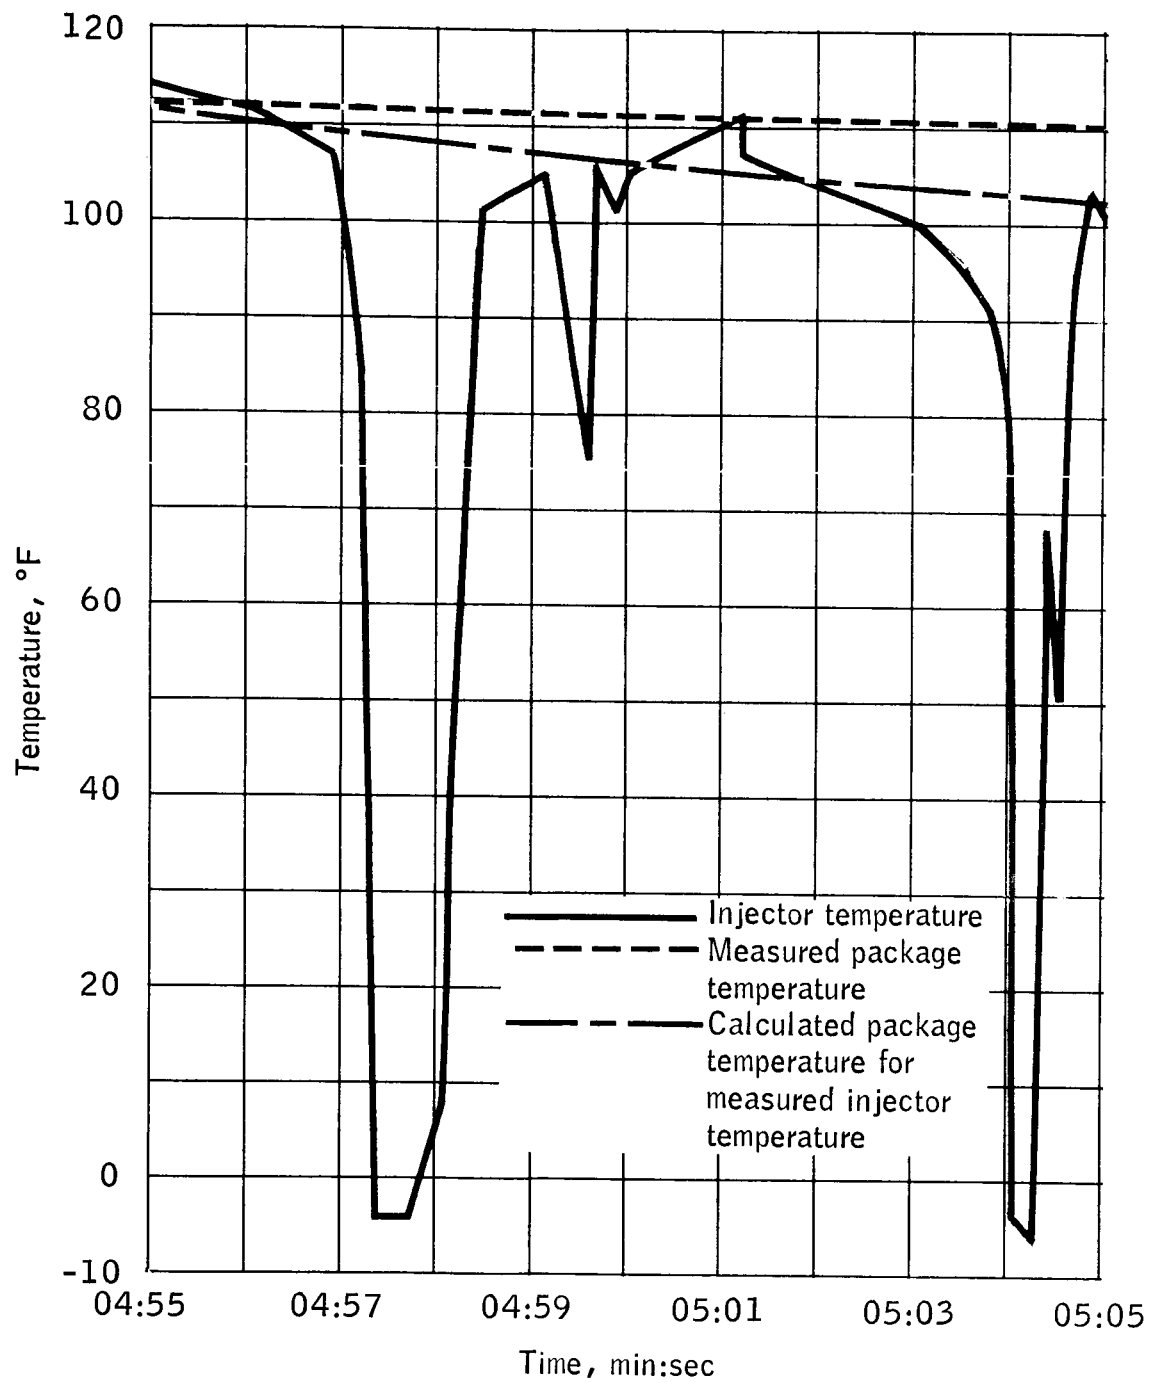
Figure 1.- Injector and package temperatures.

During four intervals in the cold-soak period, the indicated temperature of the injector for the clockwise roll engine in quad C decreased sharply from approximately 110° F to below 0° F and recovered at essentially the same rate (fig. 1). Rates of change were as high as 55° F/sec. Temperature changes caused by environmental conditions were several times slower, and no other temperature measurement showed this type of transient.

Ground tests have shown that engine pulse-mode firings can cause injector cooling, but because of the injector mass, this cooling could not be as rapid as that experienced. Further, if the injector temperature had decreased as indicated, the engine package temperature (fig. 2) would have dropped as shown in figure 1. An intermittent propellant leak could have chilled the injector transducer; however, no subsequent heating rate could account for the rapid temperature recovery.

The cause of the temperature excursions is unknown. The most likely cause was a faulty connection to the transducer.

No corrective action is required. This measurement is not mandatory for flight control, and excursions of this type will not affect system analysis.
